HETA 88-369-2141
SEPTEMBER 1991
RAYMOND W. BLISS ARMY
CIH COMMUNITY HOSPITAL
FT. HUACHUCA, ARIZONA

I. SUMMARY

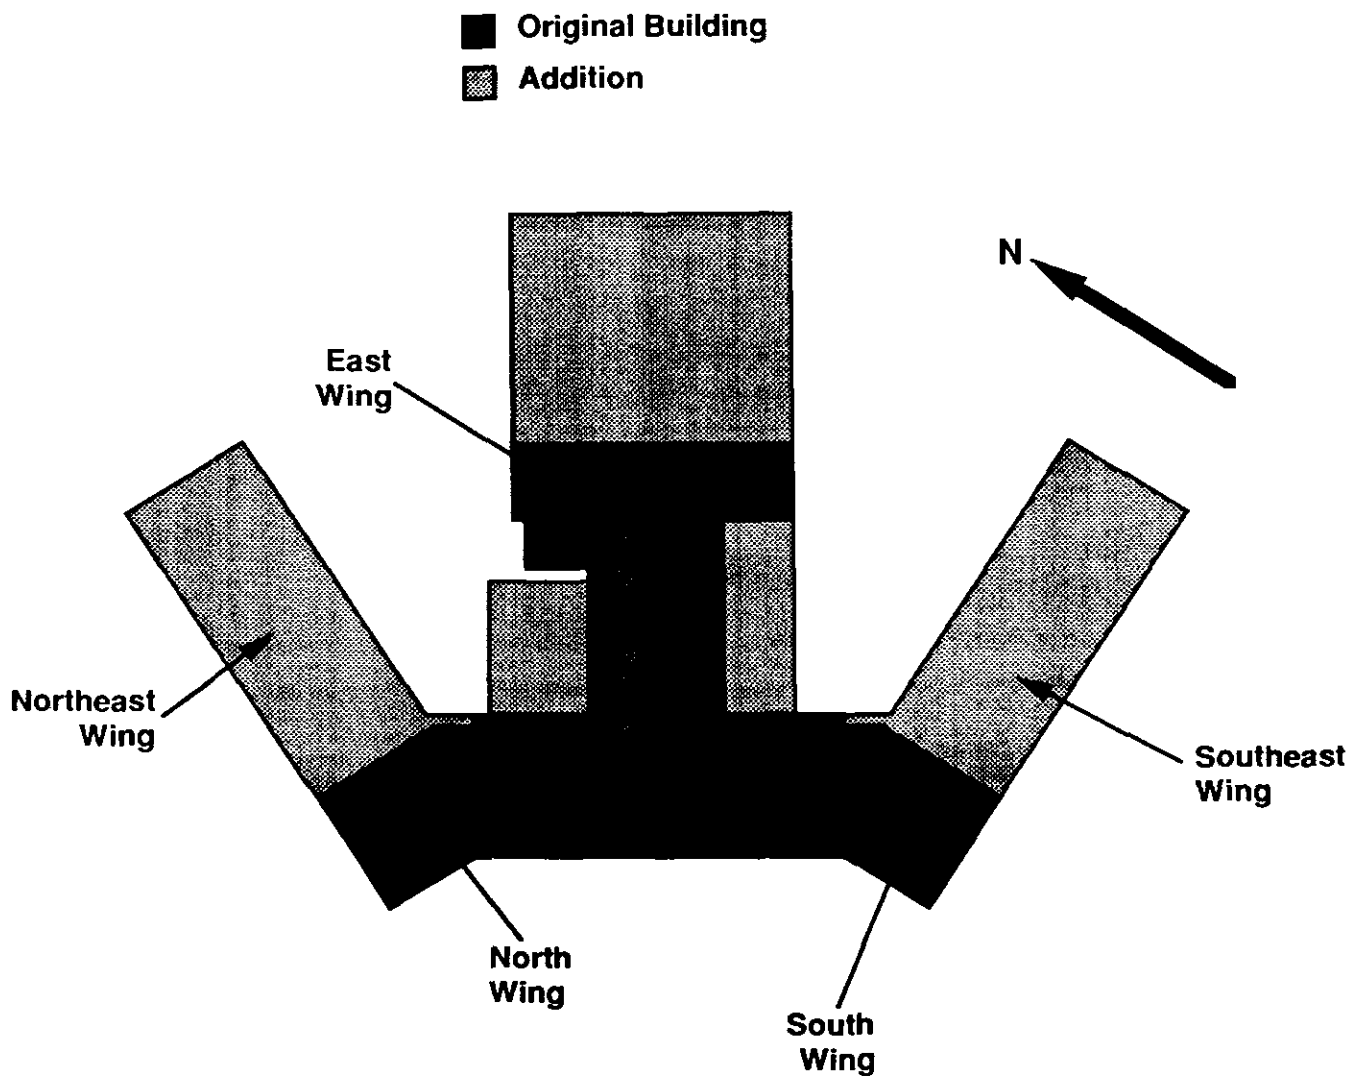
**Figure 1. Greely Hall Building Layout.
Ft. Huachuca Army Base
Ft. Huachuca, AR
88-369**

Greely Hall was apparently built in two parts as shown by Figure 1. The original building, composed of the North, South, and East Wings, was constructed in the late 1950s. The Northeast and Southeast Wings were added sometime in the early 1960s. Originally, the building was used as an electronics development laboratory and had many open areas. However, the building was changed to primarily offices by adding walls in the open areas to create more offices. Currently, the building is a mix of small, enclosed office areas and large open areas. The construction of the area is usually dictated by the group which is occupying that part of the building. Future plans are to convert the building to a classroom facility.
